A SYSTEMATIC APPROACH TO IDENTIFYING OPPORTUNITIES FOR MAKING SYSTEMS CONTEXT AWARE TO ADDRESS SAFETY HAZARDS

THESIS

Jared R. Rodriguez

September 2020

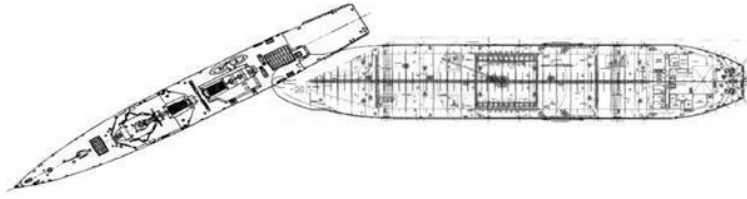
Approximately three minutes after the reported loss of steering, JOHN S MCCAIN regained positive steering control at another control station, known as Aft Steering, and the Lee Helm gained control of both throttles for speed and corrected the mismatch between the port and starboard shafts. These actions were too late, and at approximately 0524 JOHN S MCCAIN crossed in front of ALNIC's bow and collided. See Figure 6.

Figure 7 – Approximate Geometry and Point of Impact between USS JOHN S MCCAIN and ALNIC MC

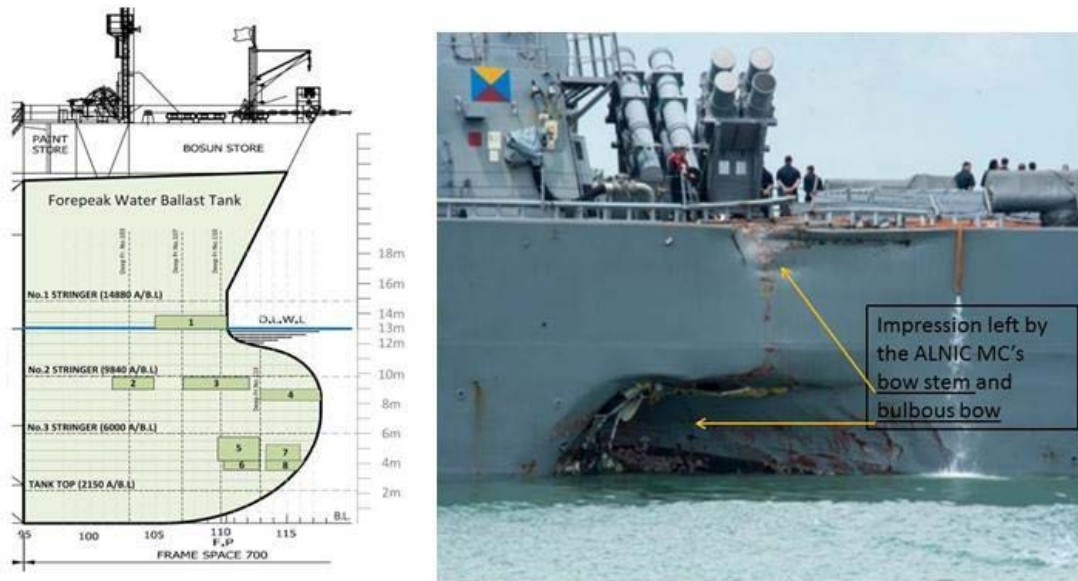
The bulbous bow of ALNIC MC impacted JOHN S MCCAIN on the port (left) aft side. The impact created a 28-foot diameter hole both below and above the waterline of the JOHN S MCCAIN. See Figures 7, 8, and 9.

Figure 8 – Bulbous bow of Figure 9 – Point of impact on JOHN S MCCAIN ALINIC MC and damage to from ALINIC MC hull from bow to stern

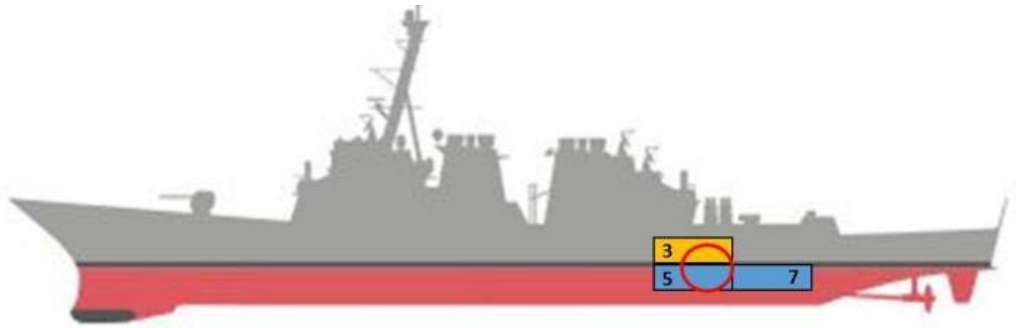
The point of impact was centered on Berthings 3 and 5 as noted in Figure 9. All significant injuries occurred to Sailors that were in Berthing 3 at the time of the impact. All ten of the fallen Sailors were in Berthing 5 at the time of impact.

Figure 10 - Depiction of Approximate Location of Point of Impact

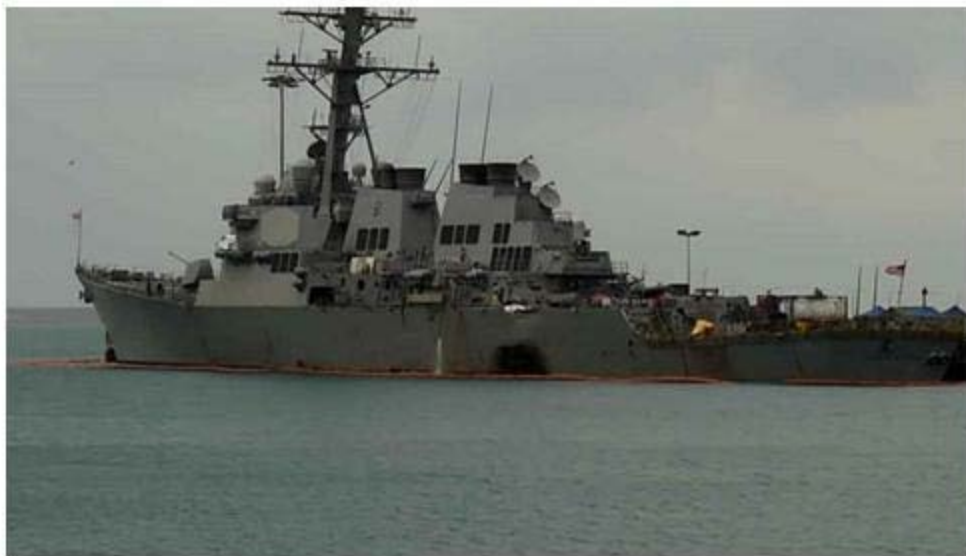
A team of Navy Divers arrived on JOHN S MCCAIN as the ship entered the harbor in Singapore at approximately 1200 on 21 August 2017. They began inspecting the ship to determine how best to proceed with a dive inside the ship. The leader of the dive team inspected Berthing 3 and saw waves breaking into the ship. The divers discovered the hole in the port side of JOHN S MCCAIN that was approximately 28 feet wide. See Figure 18.

Figure 19 – Port side of JOHN S MCCAIN post-collision
